Flood Control Project Maintenance
Levee Inspections

Fall 2013 Levee Maintenance Deficiency Summary Report

Sacramento River Basin

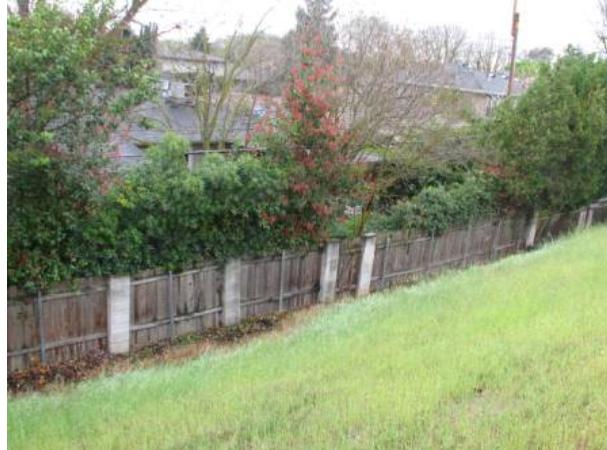
Levee Mile Report Line	27
Start Levee Mile	4.02
End Levee Mile	4.02
Location	Land Side
Category	Earthen Levee
Item	Encroachments
03/16/2012 Wood privacy fence completely obstructs access and visibility.	
mkhashch_f_20130923_888.jpg

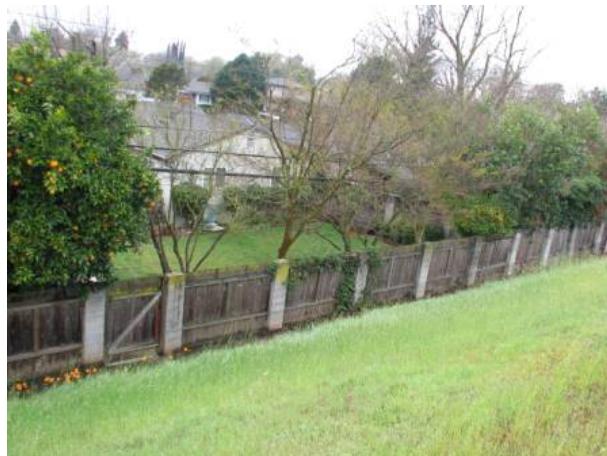
Levee Mile Report Line	28
Start Levee Mile	4.03
End Levee Mile	4.03
Location	Land Side
Category	Earthen Levee
Item	Encroachments
03/16/2012 Wood privacy fence completely obstructs access and visibility.	
mkhashch_f_20130923_889.jpg

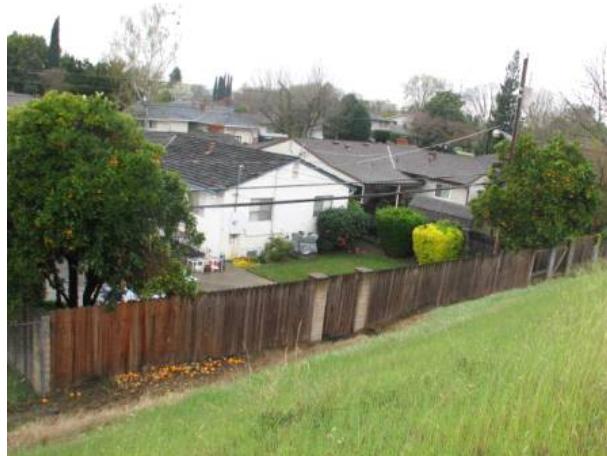
Levee Mile Report Line	29
Start Levee Mile	4.04
End Levee Mile	4.04
Location	Land Side
Category	Earthen Levee
Item	Encroachments
03/16/2012 Wood privacy fence completely obstructs access and visibility.	
mkhashch_f_20130923_890.jpg

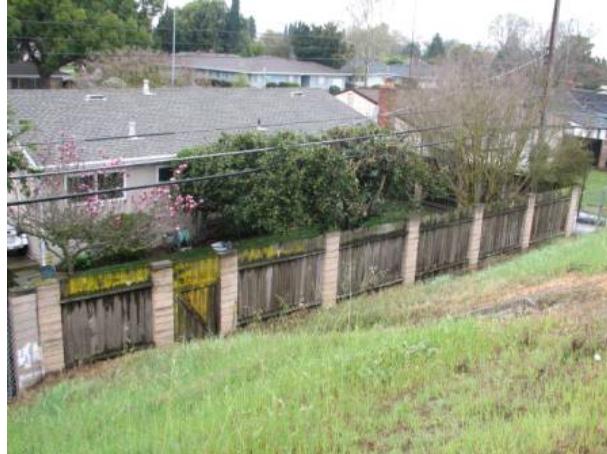
Levee Mile Report Line	30
Start Levee Mile	4.07
End Levee Mile	4.07
Location	Land Side
Category	Earthen Levee
Item	Encroachments
03/16/2012 Wood privacy fence completely obstructs access and visibility.	
mkhashch_f_20130923_891.jpg

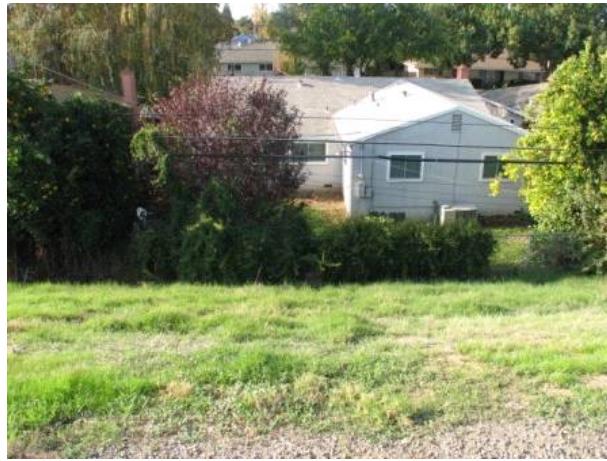
Levee Mile Report Line	31
Start Levee Mile	4.08
End Levee Mile	4.08
Location	Land Side
Category	Earthen Levee
Item	Vegetation
Fall 2009 photo: Landscaping within 10-ft of levee toe obstructs access and visibility.	
mkhashch_f_20130923_036.jpg

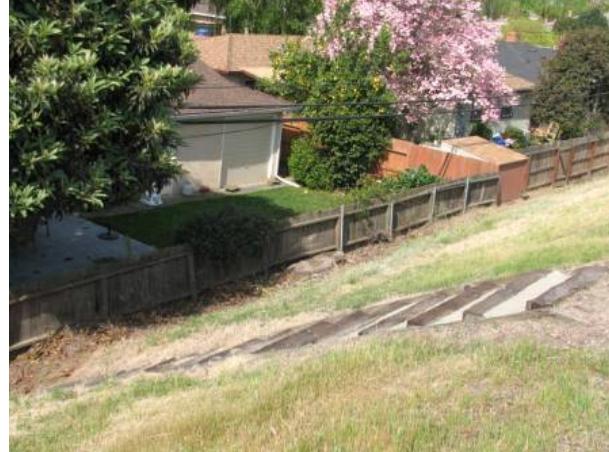
Levee Mile Report Line	33
Start Levee Mile	4.10
End Levee Mile	4.10
Location	Land Side
Category	Earthen Levee
Item	Vegetation
04/14/2011 Palms have been removed.	
mkhashch_f_20130923_893.jpg

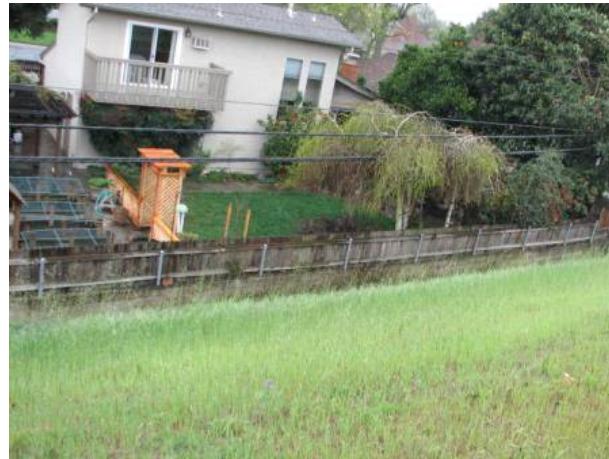
Levee Mile Report Line	34
Start Levee Mile	4.11
End Levee Mile	4.11
Location	Land Side
Category	Earthen Levee
Item	Encroachments
03/16/2012 Wood privacy fence completely obstructs access and visibility.	
mkhashch_f_20130923_894.jpg

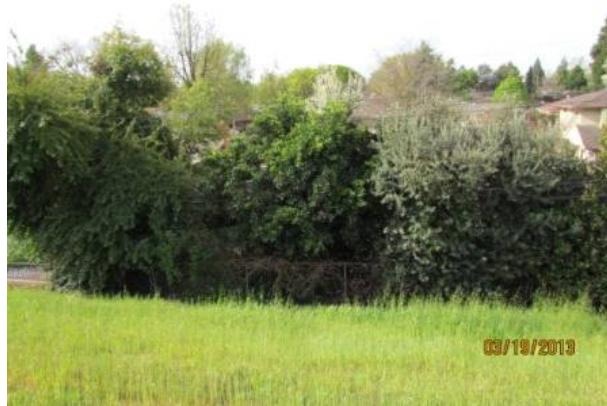
Levee Mile Report Line	36
Start Levee Mile	4.13
End Levee Mile	4.13
Location	Land Side
Category	Earthen Levee
Item	Vegetation

View of the obstructing vegetation at levee toe.

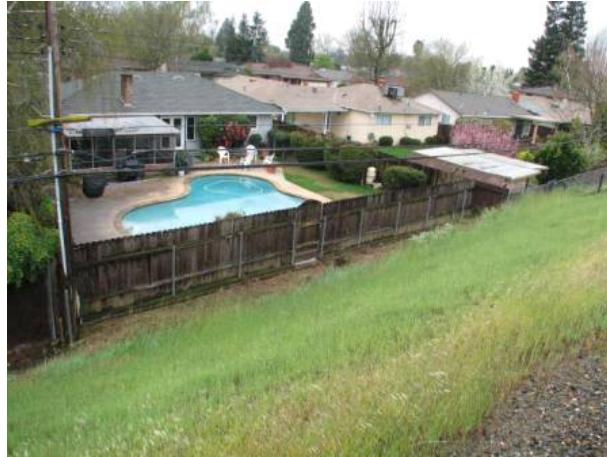
Levee Mile Report Line	39
Start Levee Mile	4.17
End Levee Mile	4.17
Location	Land Side
Category	Earthen Levee
Item	Vegetation

03/16/2012 Wood privacy fence completely obstructs access and visibility.

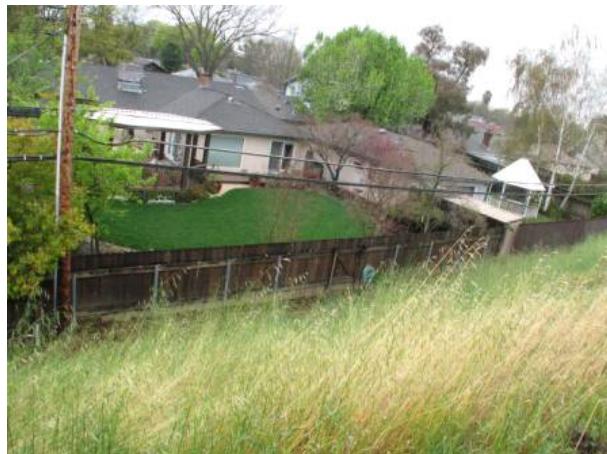
Levee Mile Report Line	40
Start Levee Mile	4.19
End Levee Mile	4.19
Location	Land Side
Category	Earthen Levee
Item	Encroachments

03/16/2012 Wood privacy fence completely obstructs access and visibility.

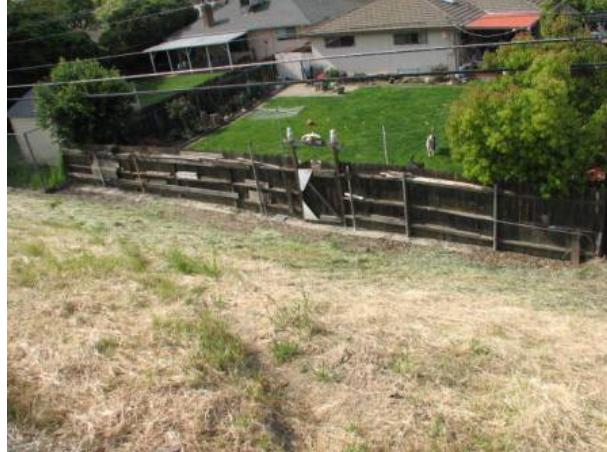
Levee Mile Report Line	41
Start Levee Mile	4.21
End Levee Mile	4.21
Location	Land Side
Category	Earthen Levee
Item	Encroachments
04/14/2011 Retaining wall has been removed. Wooden fence remains and is obstructing access and visibility.	
mkhashch_f_20130923_896.jpg

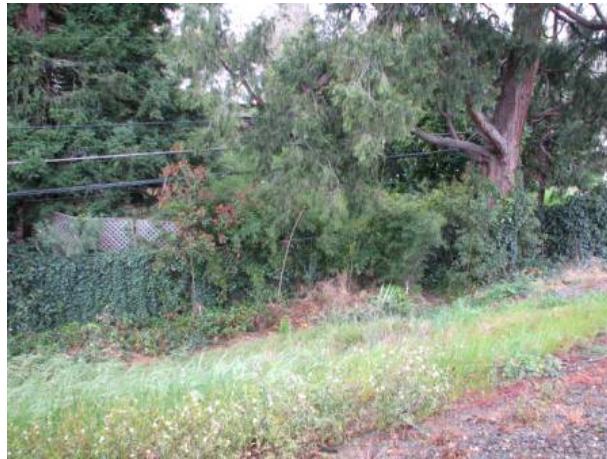
Levee Mile Report Line	42
Start Levee Mile	4.23
End Levee Mile	4.23
Location	Land Side
Category	Earthen Levee
Item	Vegetation
03/16/2012 Landscaping on fence obstructs visibility and access.	
mkhashch_f_20130923_040.jpg

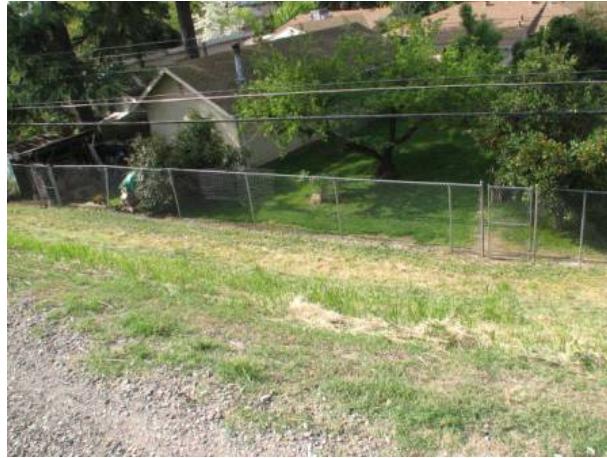
Levee Mile Report Line	44
Start Levee Mile	4.27
End Levee Mile	4.27
Location	Land Side
Category	Earthen Levee
Item	Encroachments
04/14/2011 Planter boxes have been removed. Chainlink fence partially blocks access.	
mkhashch_f_20130923_041.jpg

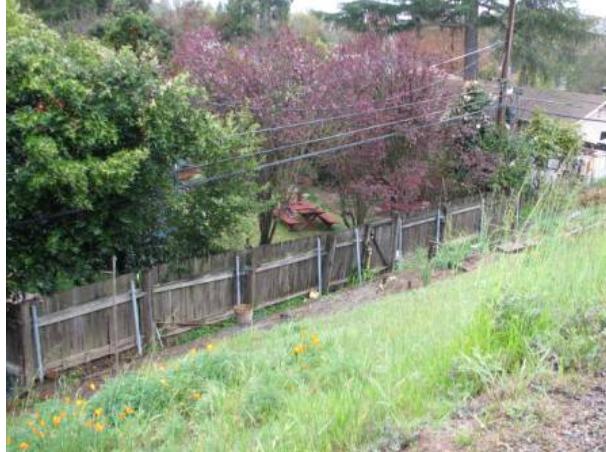
Levee Mile Report Line	45
Start Levee Mile	4.29
End Levee Mile	4.29
Location	Land Side
Category	Earthen Levee
Item	Encroachments
03/16/2012 Wood privacy fence completely obstructs access and visibility.	
mkhashch_f_20130923_897.jpg

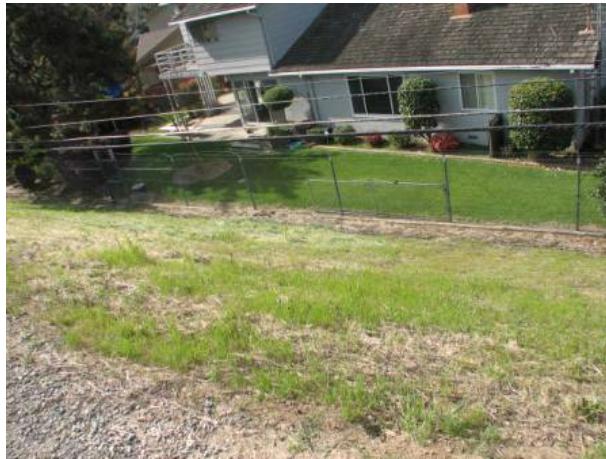
Levee Mile Report Line	46
Start Levee Mile	4.31
End Levee Mile	4.31
Location	Land Side
Category	Earthen Levee
Item	Encroachments
04/14/2011 Landscape removed, chainlink fence remains.	
mkhashch_f_20130923_042.jpg

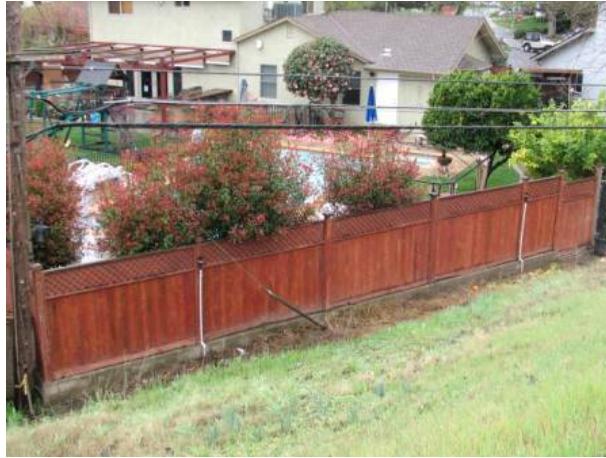
Levee Mile Report Line	47
Start Levee Mile	4.33
End Levee Mile	4.33
Location	Land Side
Category	Earthen Levee
Item	Encroachments
03/16/2012 Wood privacy fence completely obstructs access and visibility.	
mkhashch_f_20130923_898.jpg

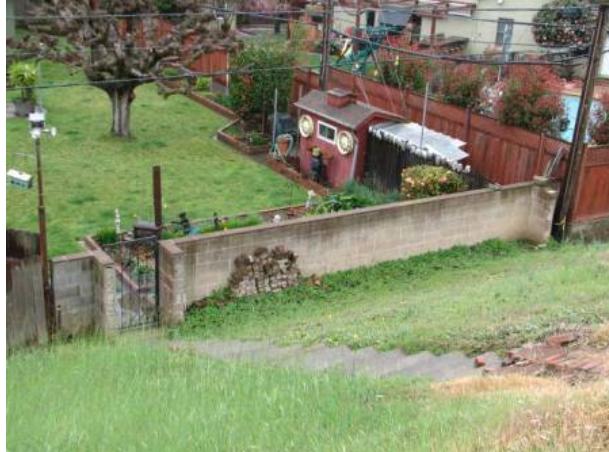
Levee Mile Report Line	48
Start Levee Mile	4.33
End Levee Mile	4.33
Location	Land Side
Category	Earthen Levee
Item	Encroachments
03/16/2012 Cinder block wall obstructs visibility and access.	
mkhashch_f_20130923_899.jpg

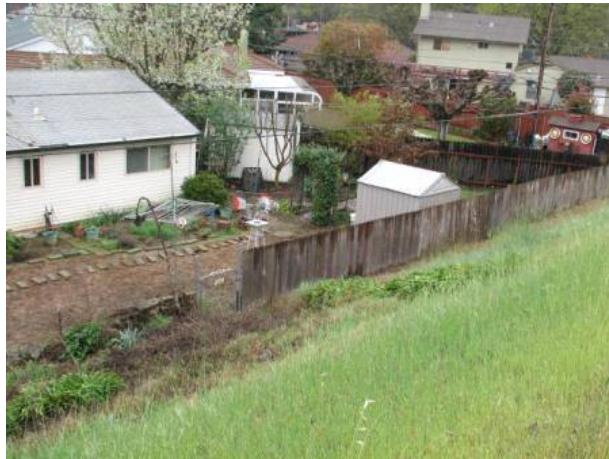
Levee Mile Report Line	49
Start Levee Mile	4.35
End Levee Mile	4.35
Location	Land Side
Category	Earthen Levee
Item	Encroachments
03/16/2012 Flowering bush is dormant, landscaping on levee slope and wooden privacy fence.	
mkhashch_f_20130923_900.jpg

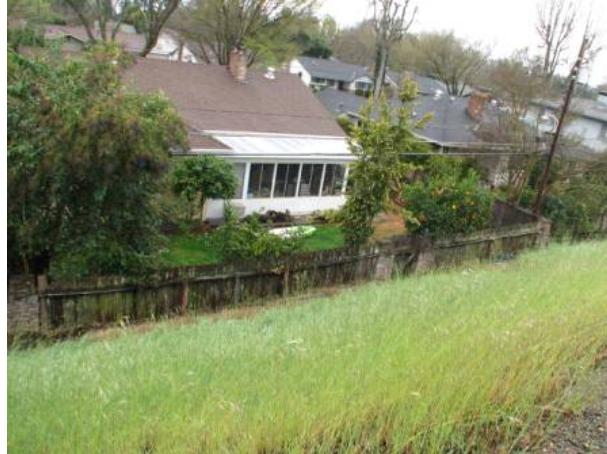
Levee Mile Report Line	52
Start Levee Mile	4.41
End Levee Mile	4.41
Location	Land Side
Category	Earthen Levee
Item	Encroachments
03/16/2012 Wood privacy fence completely obstructs access and visibility.	
mkhashch_f_20130923_901.jpg

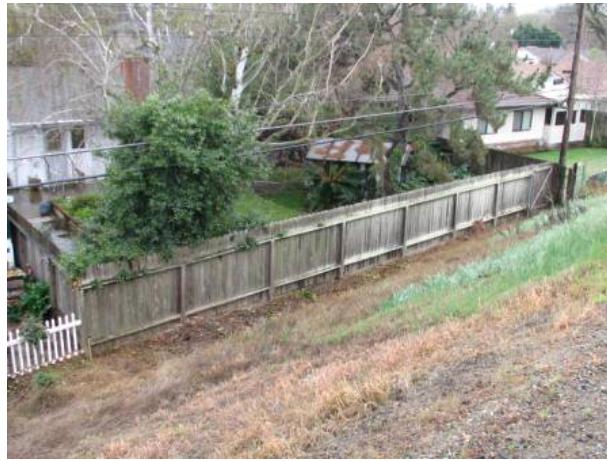
Levee Mile Report Line	53
Start Levee Mile	4.45
End Levee Mile	4.45
Location	Land Side
Category	Earthen Levee
Item	Encroachments
03/16/2012 Wood privacy fence completely obstructs access and visibility.	
mkhashch_f_20130923_902.jpg

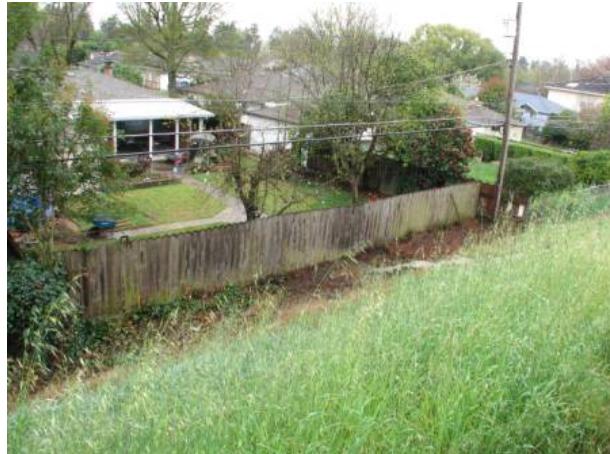
Levee Mile Report Line	57
Start Levee Mile	4.52
End Levee Mile	4.52
Location	Land Side
Category	Earthen Levee
Item	Encroachments
03/16/2012 Wood privacy fence completely obstructs access and visibility.	
mkhashch_f_20130923_903.jpg

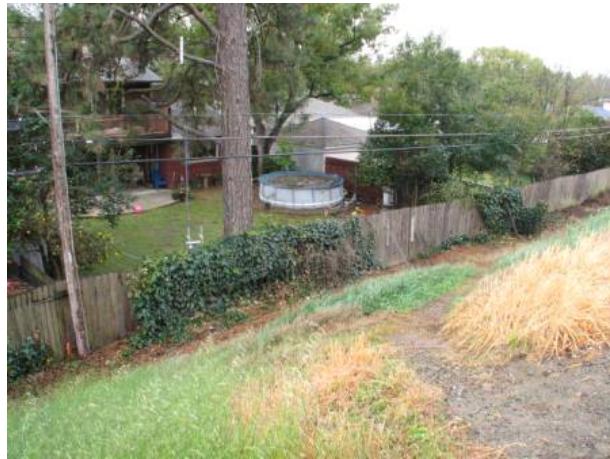
Levee Mile Report Line	58
Start Levee Mile	4.53
End Levee Mile	4.53
Location	Land Side
Category	Earthen Levee
Item	Encroachments
03/16/2012 Wood privacy fence completely obstructs access and visibility.	
mkhashch_f_20130923_044.jpg

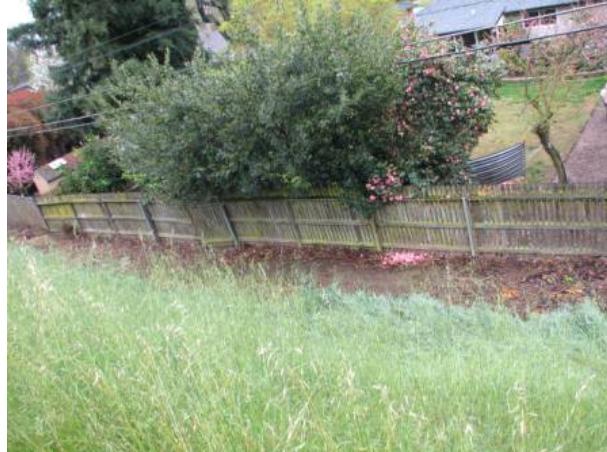
Levee Mile Report Line	60
Start Levee Mile	4.55
End Levee Mile	4.55
Location	Land Side
Category	Earthen Levee
Item	Encroachments
03/16/2012 Wood privacy fence completely obstructs access and visibility.	
mhashch_f_20130923_046.jpg

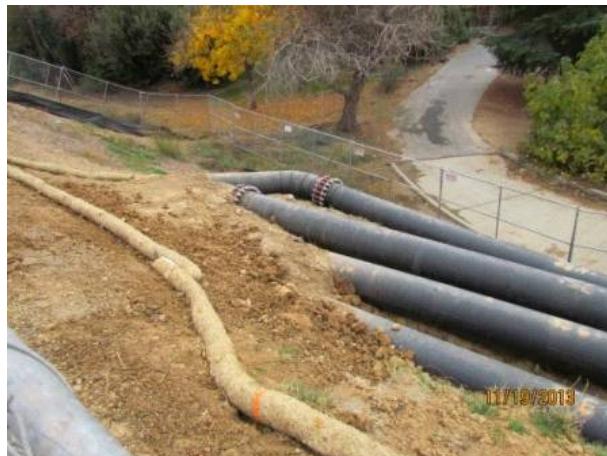
Levee Mile Report Line	62
Start Levee Mile	4.60
End Levee Mile	4.60
Location	Crown
Category	Earthen Levee
Item	Encroachments
View of the temporary pipes penetrating the landside levee slope.	
mhashch_f_20131120_729.JPG

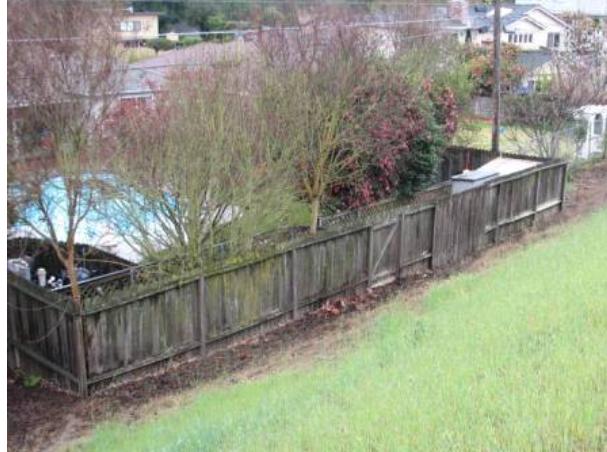
Levee Mile Report Line	70
Start Levee Mile	4.77
End Levee Mile	4.77
Location	Land Side
Category	Earthen Levee
Item	Encroachments
03/16/2012 Wood privacy fence completely obstructs access and visibility.	
mhashch_f_20130923_906.jpg

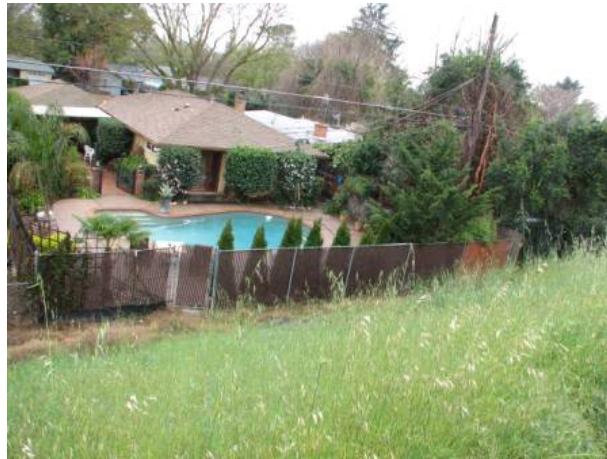
Levee Mile Report Line	71
Start Levee Mile	4.82
End Levee Mile	4.82
Location	Land Side
Category	Earthen Levee
Item	Encroachments
03/16/2012 Chainlink fence with privacy slats obstructs visibility and access.	
mhashch_f_20130923_048.jpg

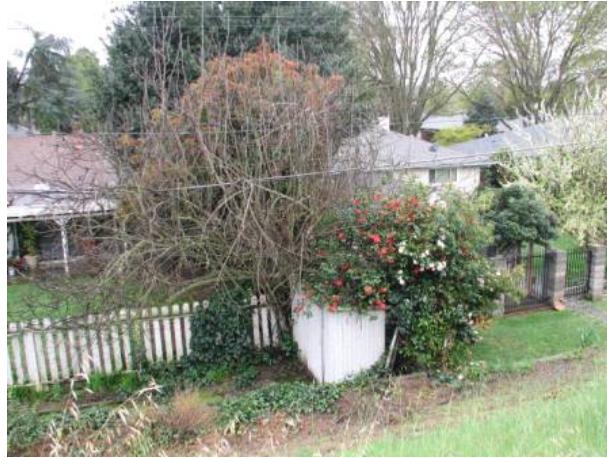
Levee Mile Report Line	73
Start Levee Mile	4.87
End Levee Mile	4.87
Location	Land Side
Category	Earthen Levee
Item	Vegetation
03/16/2012 Landscaping obstructs visibility and access.	
mhashch_f_20130923_049.jpg

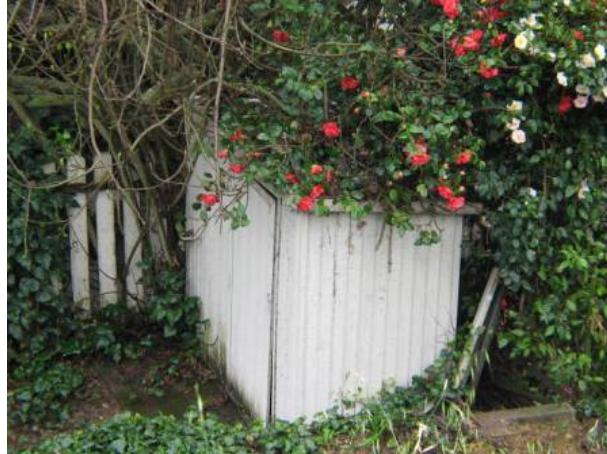
Levee Mile Report Line	74
Start Levee Mile	4.87
End Levee Mile	4.87
Location	Land Side
Category	Earthen Levee
Item	Encroachments
3/16/2012 Structure is within 15' of levee toe.	
mkhashch_f_20130923_950.jpg

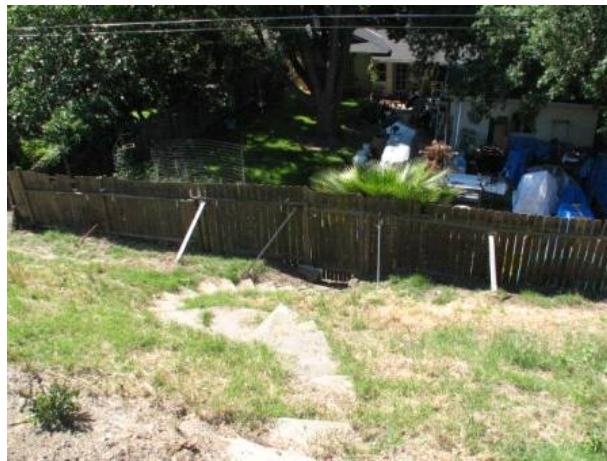
Levee Mile Report Line	76
Start Levee Mile	4.93
End Levee Mile	4.93
Location	Land Side
Category	Earthen Levee
Item	Encroachments
Wooden fence and braces obstruct access and visibility.	
mkhashch_f_20130923_907.jpg

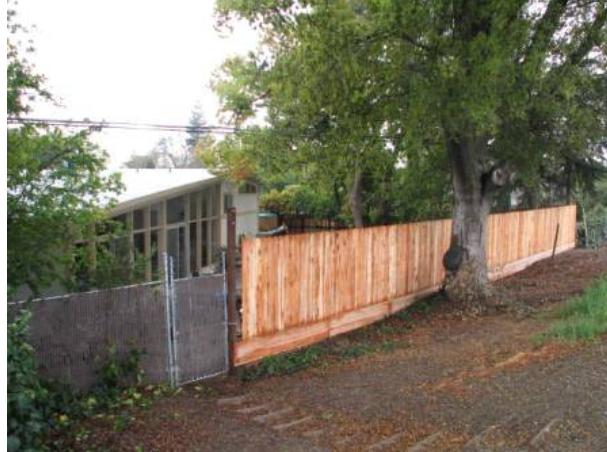
Levee Mile Report Line	78
Start Levee Mile	5.13
End Levee Mile	5.13
Location	Land Side
Category	Earthen Levee
Item	Encroachments
03/16/2012 Wood privacy fence completely obstructs access and visibility.	
mkhashch_f_20130923_050.jpg

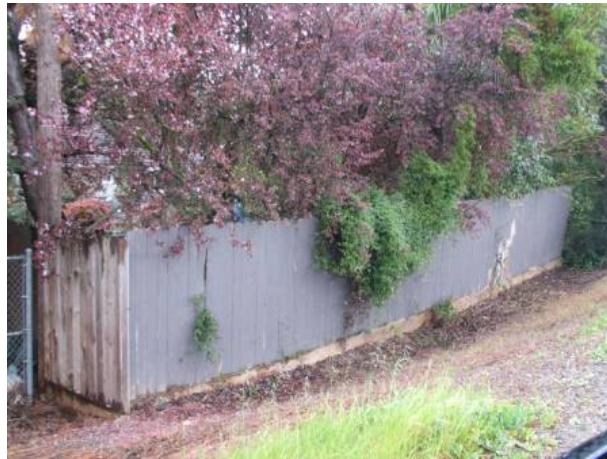
Levee Mile Report Line	80
Start Levee Mile	5.17
End Levee Mile	5.17
Location	Land Side
Category	Earthen Levee
Item	Encroachments
03/16/2012 Wood privacy fence completely obstructs access and visibility.	
mkhashch_f_20130923_909.jpg

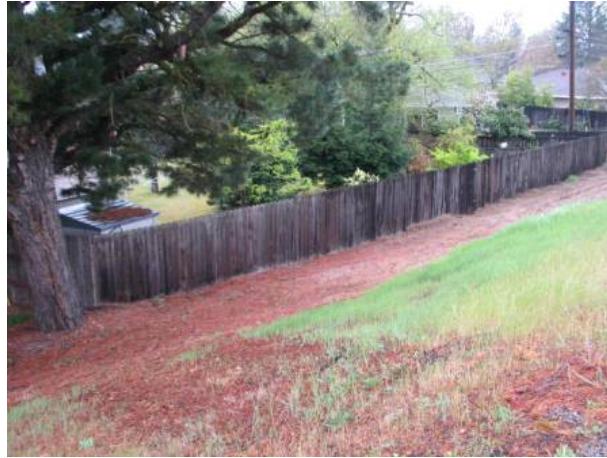
Levee Mile Report Line	81
Start Levee Mile	5.45
End Levee Mile	5.45
Location	Land Side
Category	Earthen Levee
Item	Encroachments
03/16/2012 Wood privacy fence completely obstructs access and visibility.	
mkhashch_f_20130923_910.jpg

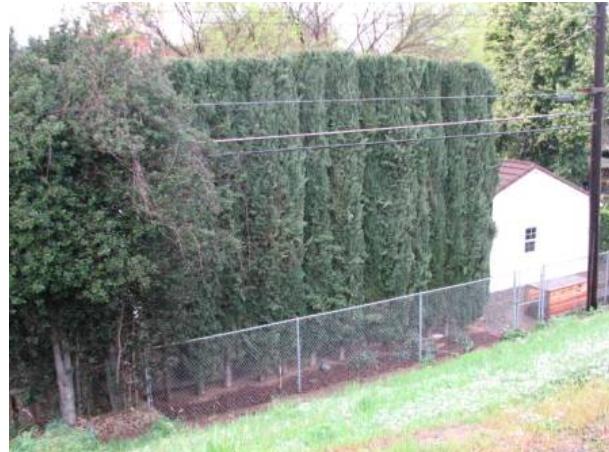
Levee Mile Report Line	85
Start Levee Mile	5.61
End Levee Mile	5.61
Location	Land Side
Category	Earthen Levee
Item	Vegetation
03/16/2012 Landscaping obstructs visibility and access.	
mkhashch_f_20130923_913.jpg

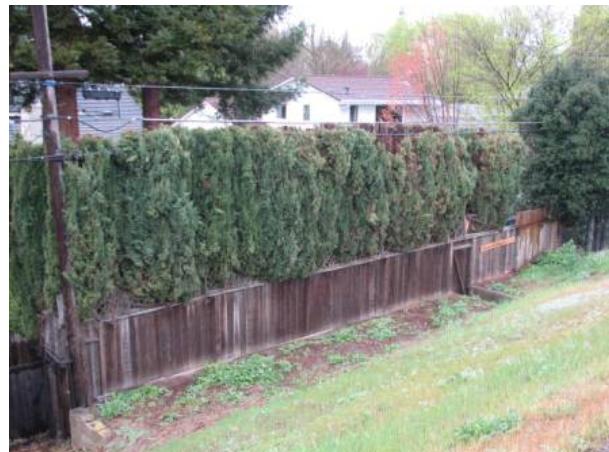
Levee Mile Report Line	86
Start Levee Mile	5.63
End Levee Mile	5.63
Location	Land Side
Category	Earthen Levee
Item	Vegetation
03/16/2012 Landscaping and fence obstruct visibility and access.	
mkhashch_f_20130923_914.jpg

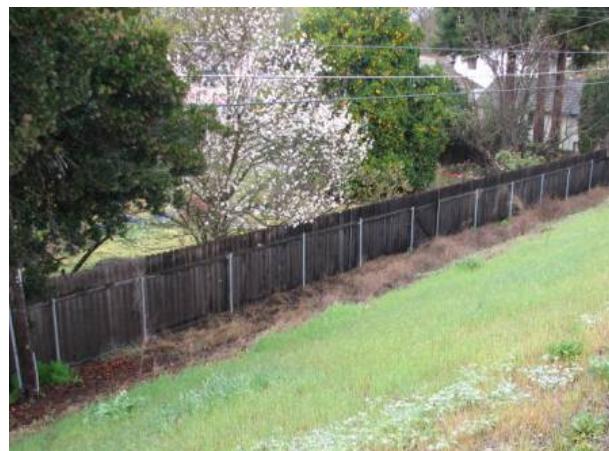
Levee Mile Report Line	87
Start Levee Mile	5.64
End Levee Mile	5.64
Location	Land Side
Category	Earthen Levee
Item	Encroachments
03/16/2012 Wood privacy fence completely obstructs access and visibility.	
mkhashch_f_20130923_915.jpg

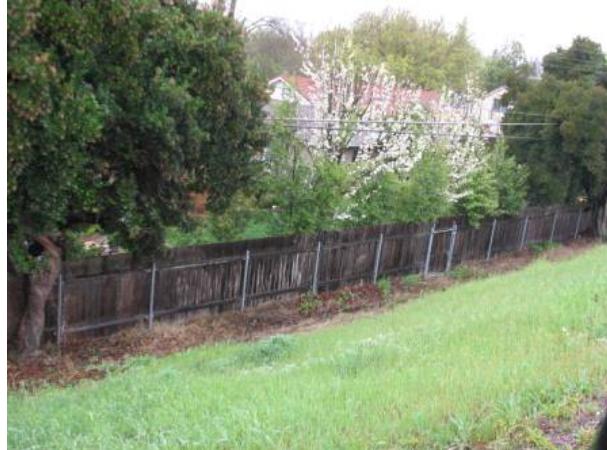
Levee Mile Report Line	88
Start Levee Mile	5.66
End Levee Mile	5.66
Location	Land Side
Category	Earthen Levee
Item	Encroachments
03/16/2012 Wood privacy fence completely obstructs access and visibility.	
mhashch_f_20130923_916.jpg

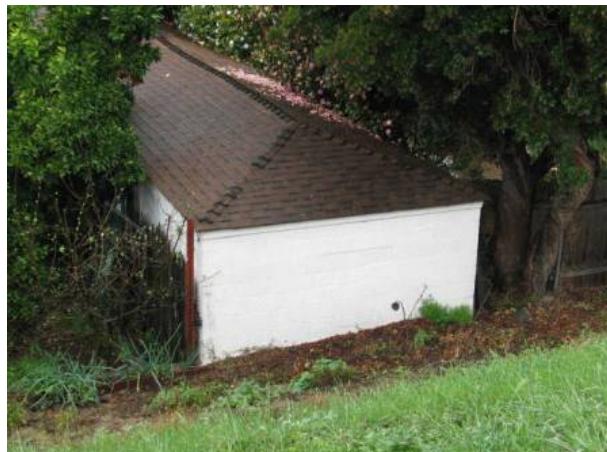
Levee Mile Report Line	89
Start Levee Mile	5.67
End Levee Mile	5.67
Location	Land Side
Category	Earthen Levee
Item	Encroachments
03/16/2012 Structure within 15' of levee toe.	
mhashch_f_20130923_917.jpg

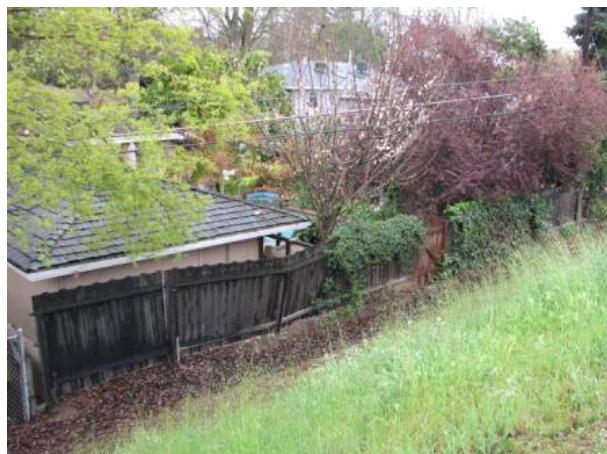
Levee Mile Report Line	90
Start Levee Mile	5.72
End Levee Mile	5.72
Location	Land Side
Category	Earthen Levee
Item	Encroachments
03/16/2012 Wood privacy fence completely obstructs access and visibility.	
mhashch_f_20130923_918.jpg

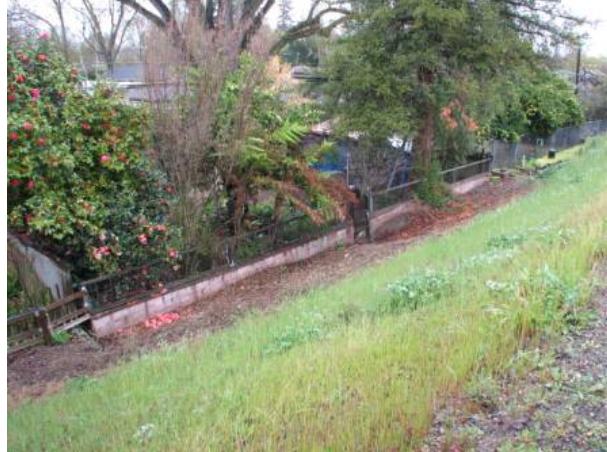
Levee Mile Report Line	92
Start Levee Mile	5.76
End Levee Mile	5.76
Location	Land Side
Category	Earthen Levee
Item	Encroachments
03/16/2012 Fence and landscaping obstruct visibility and access.	
mhashch_f_20130923_919.jpg

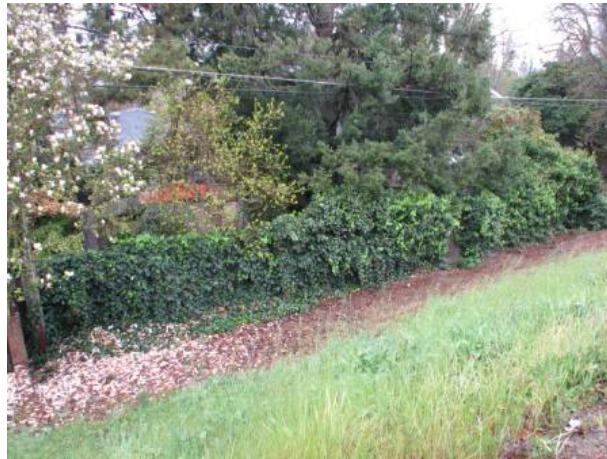
Levee Mile Report Line	94
Start Levee Mile	5.79
End Levee Mile	5.79
Location	Land Side
Category	Earthen Levee
Item	Vegetation
03/16/2012 Landscaping obstructs access and visibility.	
mhashch_f_20130923_920.jpg

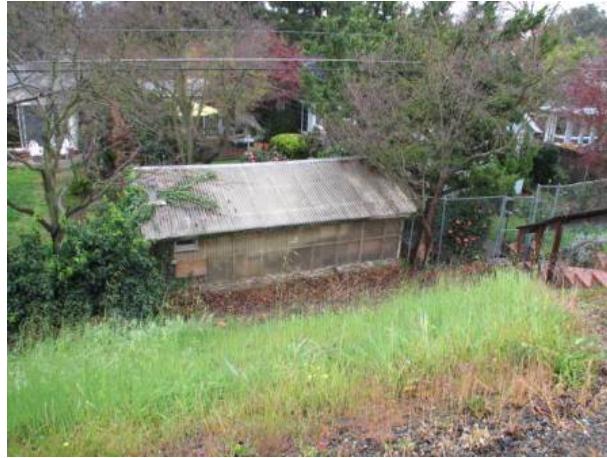
Levee Mile Report Line	96
Start Levee Mile	5.83
End Levee Mile	5.83
Location	Land Side
Category	Earthen Levee
Item	Encroachments
03/16/2012 Wood and fiberglass structure is within 15' of levee toe.	
mhashch_f_20130923_921.jpg

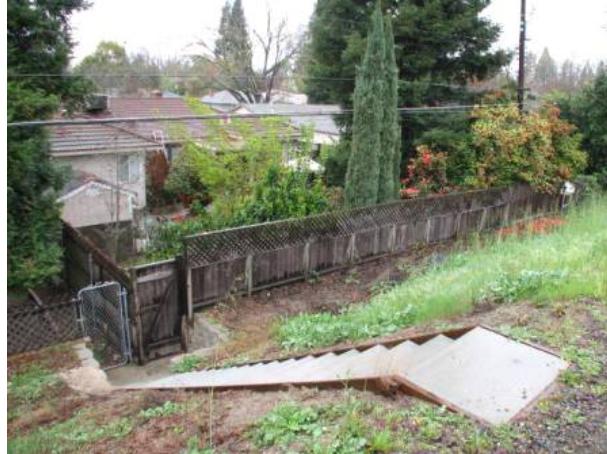
Levee Mile Report Line	98
Start Levee Mile	5.85
End Levee Mile	5.85
Location	Land Side
Category	Earthen Levee
Item	Encroachments
03/16/2012 Wood privacy fence completely obstructs access and visibility.	
mkhashch_f_20130923_922.jpg

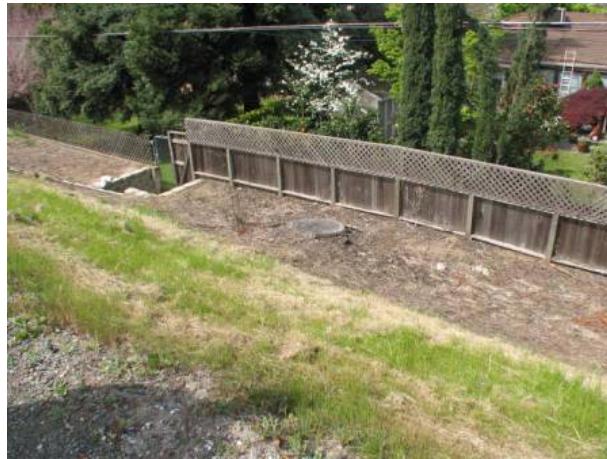
Levee Mile Report Line	99
Start Levee Mile	5.85
End Levee Mile	5.85
Location	Land Side
Category	Earthen Levee
Item	Trim / Thin Trees
04/14/2011 Large stump at toe of levee.	
mkhashch_f_20130923_033.jpg

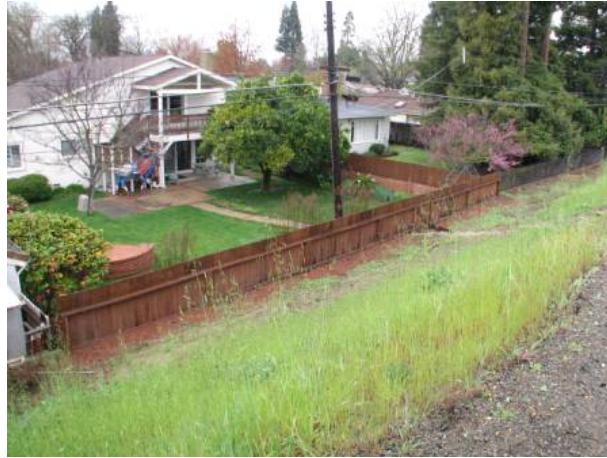
Levee Mile Report Line	100
Start Levee Mile	5.87
End Levee Mile	5.87
Location	Land Side
Category	Earthen Levee
Item	Encroachments
03/16/2012 Wood privacy fence completely obstructs access and visibility.	
mkhashch_f_20130923_051.jpg

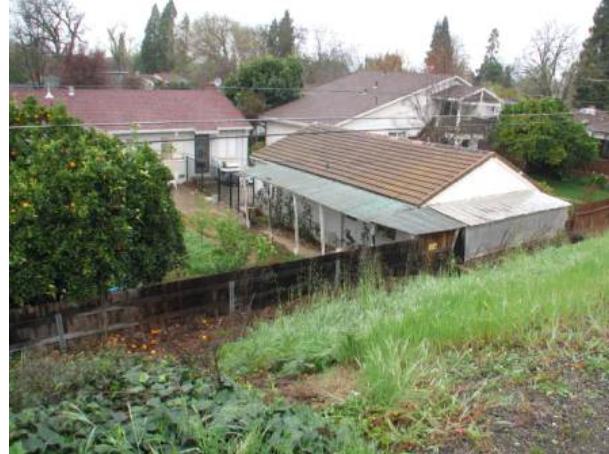
Levee Mile Report Line	101
Start Levee Mile	5.88
End Levee Mile	5.88
Location	Land Side
Category	Earthen Levee
Item	Encroachments
03/16/2012 Structure is within 15' of levee toe.	
mkhashch_f_20130923_923.jpg

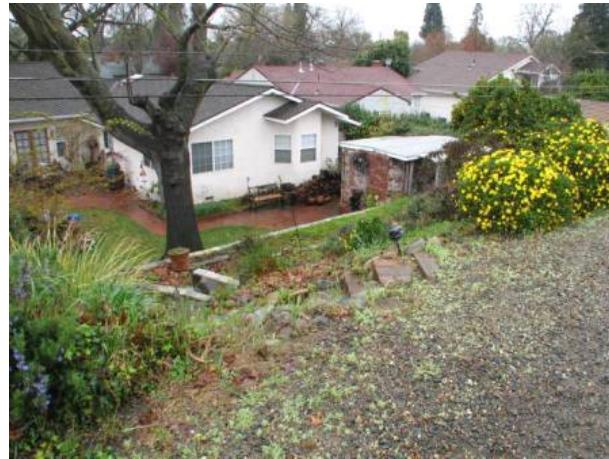
Levee Mile Report Line	102
Start Levee Mile	5.89
End Levee Mile	5.89
Location	Land Side
Category	Earthen Levee
Item	Vegetation
03/16/2012 Levee slope is heavily landscaped, retaining wall has been constructed at the levee toe.	
mkhashch_f_20130923_925.jpg

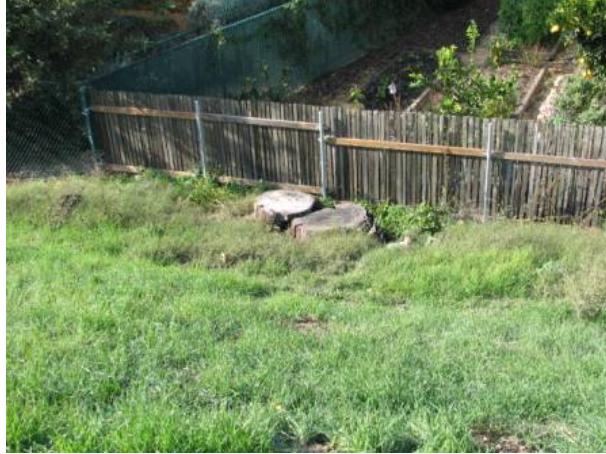
Levee Mile Report Line	106
Start Levee Mile	5.94
End Levee Mile	5.94
Location	Land Side
Category	Earthen Levee
Item	Encroachments
11/15/2011 Stump at levee toe.	
mkhashch_f_20130923_064.jpg

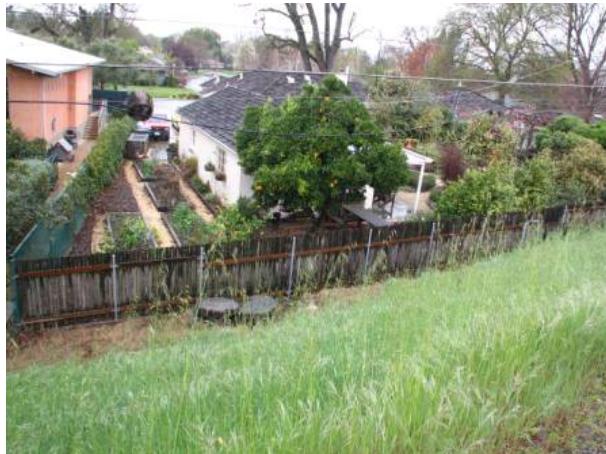
Levee Mile Report Line	107
Start Levee Mile	5.94
End Levee Mile	5.94
Location	Land Side
Category	Earthen Levee
Item	Encroachments
03/16/2012 Wood privacy fence completely obstructs access and visibility.	
mkhashch_f_20130923_942.jpg

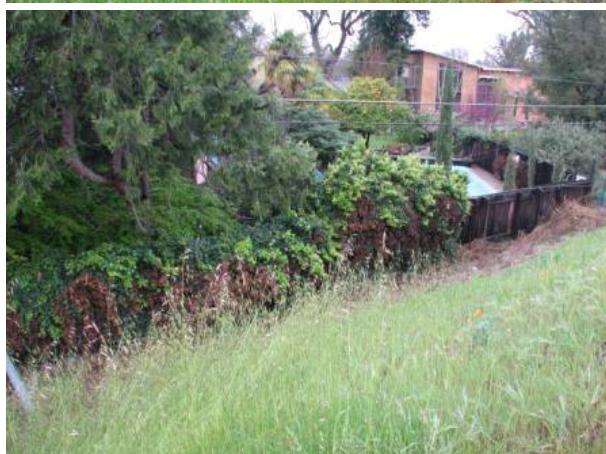
Levee Mile Report Line	109
Start Levee Mile	5.97
End Levee Mile	5.97
Location	Land Side
Category	Earthen Levee
Item	Encroachments
03/16/2012 Wood privacy fence completely obstructs access and visibility.	
mkhashch_f_20130923_926.jpg

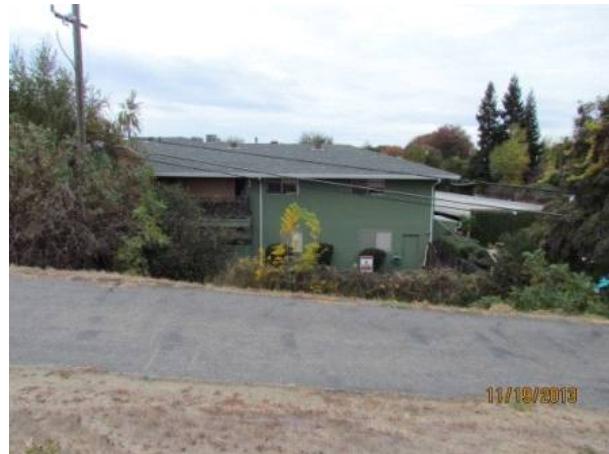
mkhashch_f_20131120_728.JPG

View of the fence at the landside levee toe.

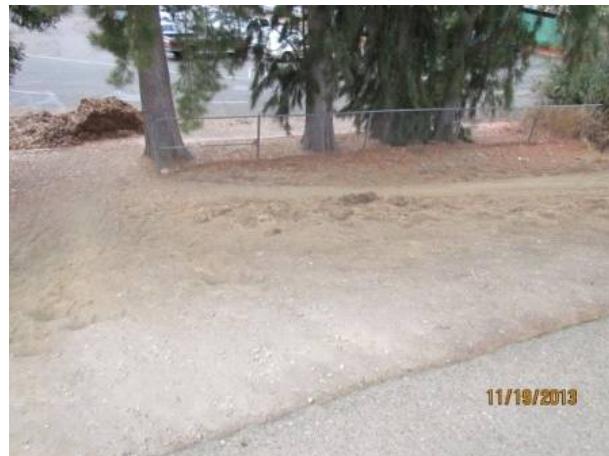
Levee Mile Report Line	112
Start Levee Mile	6.28
End Levee Mile	6.28
Location	Land Side
Category	Earthen Levee
Item	Slope Stability

View of the foot traffic on the landside levee slope.

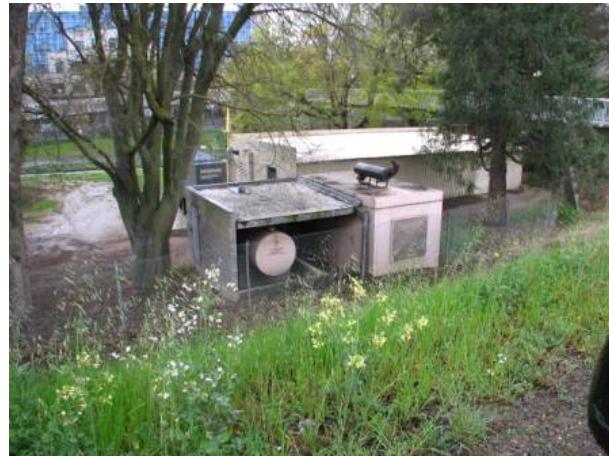
Levee Mile Report Line	113
Start Levee Mile	6.61
End Levee Mile	6.61
Location	Land Side
Category	Earthen Levee
Item	Encroachments

03/16/2012 Structure for generator is within 5' of levee toe.

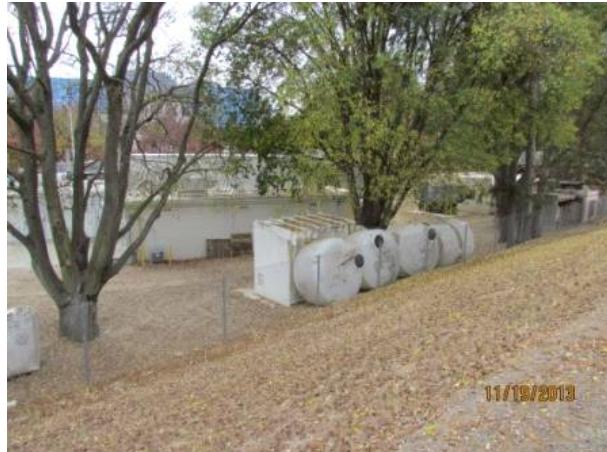
Levee Mile Report Line	114
Start Levee Mile	6.63
End Levee Mile	6.63
Location	Land Side
Category	Earthen Levee
Item	Encroachments
View of the water tanks stored at the landside levee toe.	
mhashch_f_20131120_726.JPG

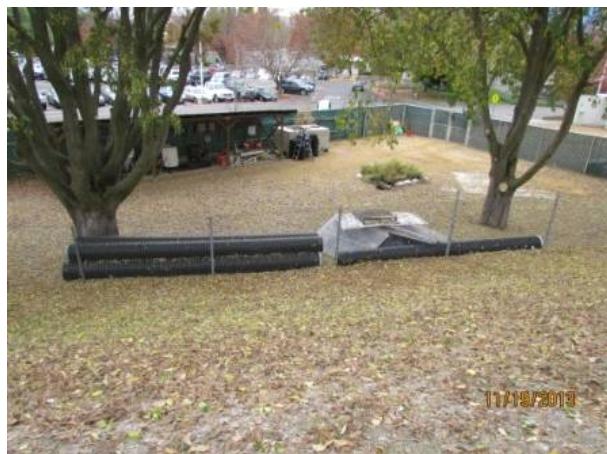
Levee Mile Report Line	115
Start Levee Mile	6.66
End Levee Mile	6.66
Location	Land Side
Category	Earthen Levee
Item	Encroachments
View of the material stored at the landside levee toe.	
mhashch_f_20131120_725.JPG

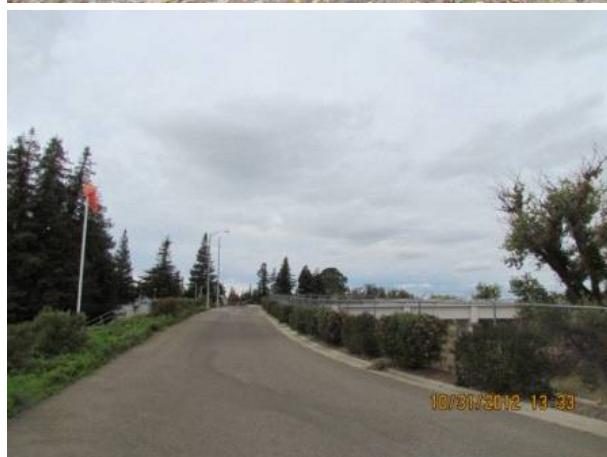
Levee Mile Report Line	116
Start Levee Mile	6.85
End Levee Mile	6.98
Location	Water Side
Category	Earthen Levee
Item	Vegetation
View of landscaping at waterside hinge obstructing visibility.	
mhashch_f_20130923_993.JPG

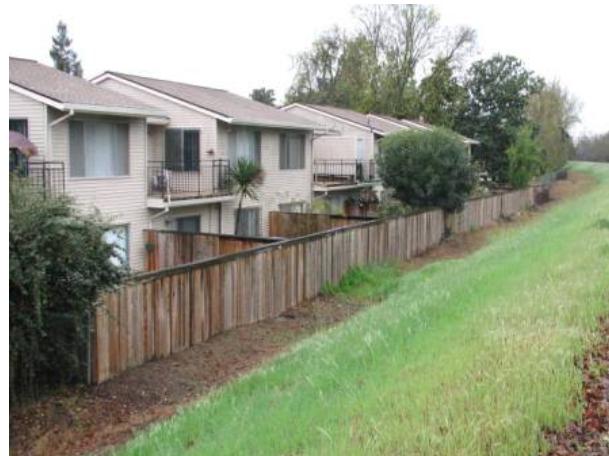
Levee Mile Report Line	118
Start Levee Mile	7.70
End Levee Mile	7.73
Location	Land Side
Category	Earthen Levee
Item	Encroachments
03/16/2012 Wood privacy fence completely obstructs access and visibility.	
mkhashch_f_20130923_928.jpg

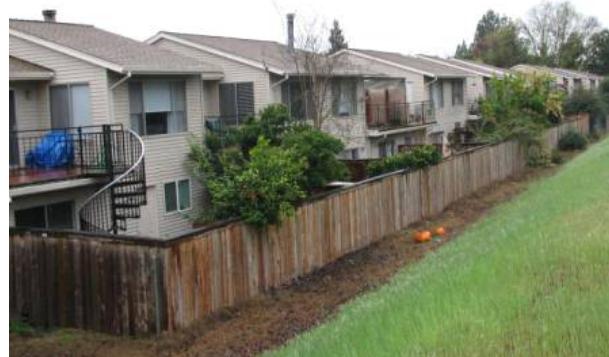
Levee Mile Report Line	119
Start Levee Mile	7.75
End Levee Mile	7.77
Location	Land Side
Category	Earthen Levee
Item	Encroachments
03/16/2012 Wood privacy fence completely obstructs access and visibility.	
mkhashch_f_20130923_929.jpg

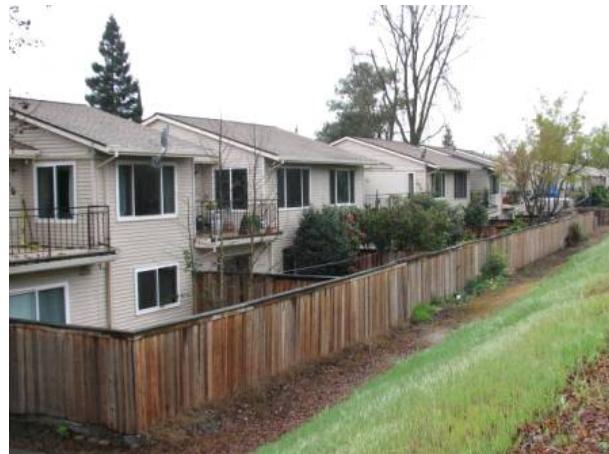
Levee Mile Report Line	120
Start Levee Mile	7.80
End Levee Mile	7.82
Location	Land Side
Category	Earthen Levee
Item	Encroachments
03/16/2012 Wood privacy fence completely obstructs access and visibility.	
mkhashch_f_20130923_930.jpg

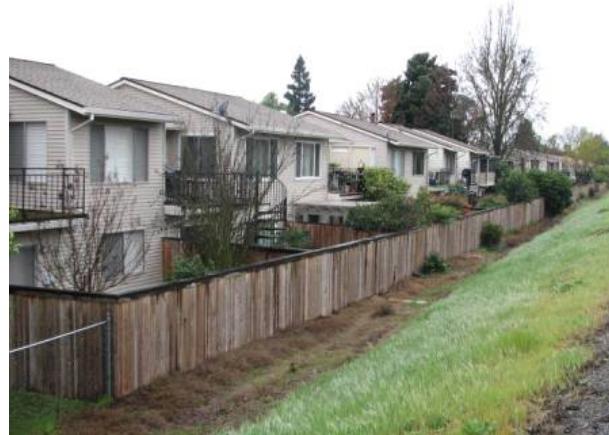
Levee Mile Report Line	121
Start Levee Mile	7.83
End Levee Mile	7.86
Location	Land Side
Category	Earthen Levee
Item	Encroachments
03/16/2012 Wood privacy fence completely obstructs access and visibility.	
mkhashch_f_20130923_931.jpg

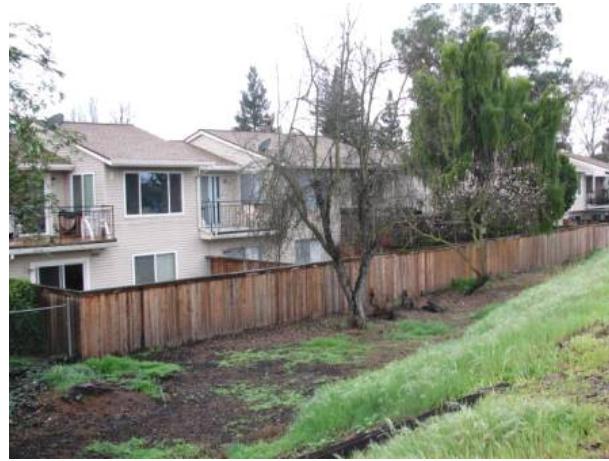
Levee Mile Report Line	122
Start Levee Mile	7.88
End Levee Mile	7.90
Location	Land Side
Category	Earthen Levee
Item	Encroachments
03/16/2012 Wood privacy fence completely obstructs access and visibility.	
mkhashch_f_20130923_932.jpg

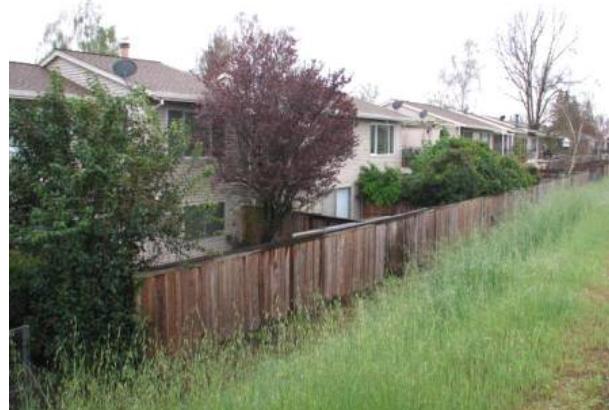
Levee Mile Report Line	124
Start Levee Mile	7.96
End Levee Mile	7.98
Location	Land Side
Category	Earthen Levee
Item	Encroachments
03/16/2012 Wood privacy fence completely obstructs access and visibility.	
mhashch_f_20130923_934.jpg

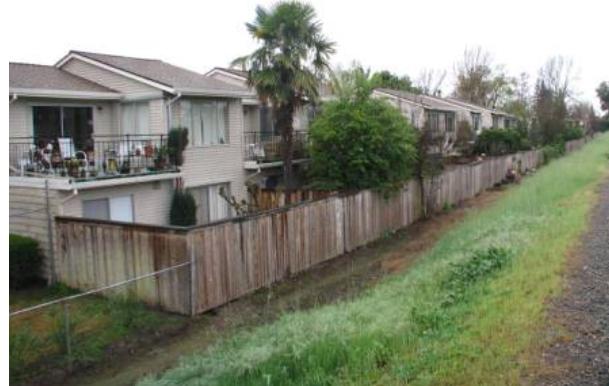
Levee Mile Report Line	126
Start Levee Mile	8.00
End Levee Mile	8.03
Location	Land Side
Category	Earthen Levee
Item	Encroachments
03/16/2012 Wood privacy fence completely obstructs access and visibility.	
mhashch_f_20130923_052.jpg

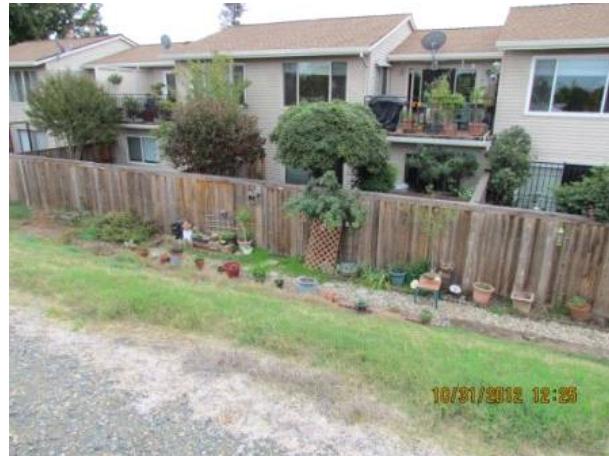
Levee Mile Report Line	127
Start Levee Mile	8.01
End Levee Mile	8.01
Location	Land Side
Category	Earthen Levee
Item	Vegetation
View of landscaping at landside levee toe.	
mhashch_f_20130923_034.JPG

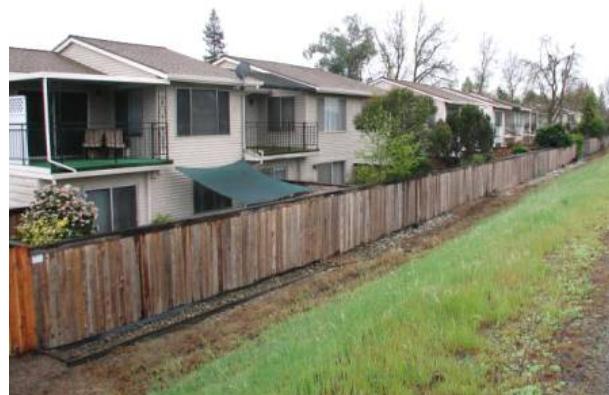
Levee Mile Report Line	128
Start Levee Mile	8.04
End Levee Mile	8.07
Location	Land Side
Category	Earthen Levee
Item	Encroachments
03/16/2012 Wood privacy fence completely obstructs access and visibility.	
mkhashch_f_20130923_935.jpg

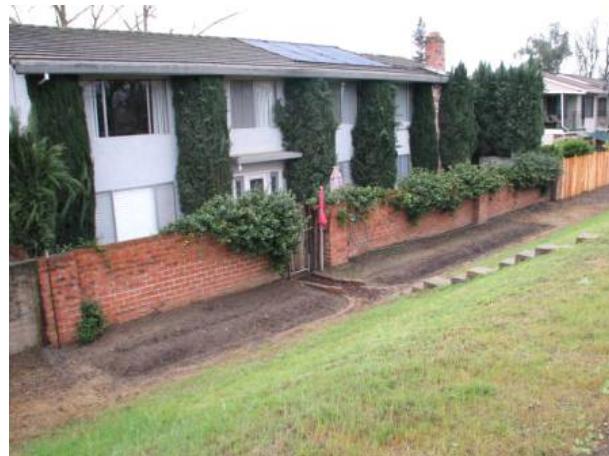
Levee Mile Report Line	129
Start Levee Mile	8.09
End Levee Mile	8.09
Location	Land Side
Category	Earthen Levee
Item	Encroachments
03/16/2012 Brick wall completely obstructs access and visibility.	
mkhashch_f_20130923_936.jpg

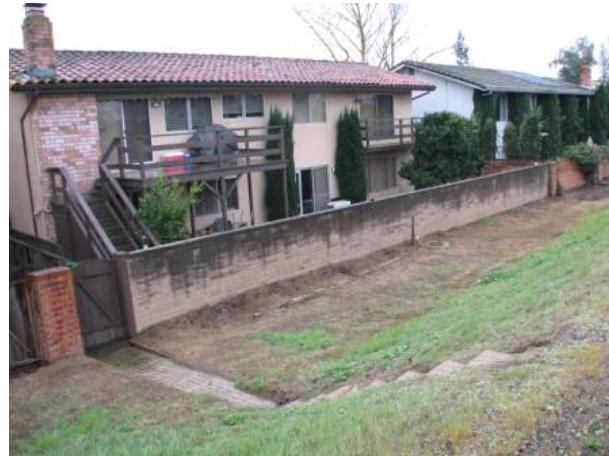
Levee Mile Report Line	130
Start Levee Mile	8.10
End Levee Mile	8.10
Location	Land Side
Category	Earthen Levee
Item	Encroachments
03/16/2012 Brick wall completely obstructs access and visibility.	
mkhashch_f_20130923_937.jpg

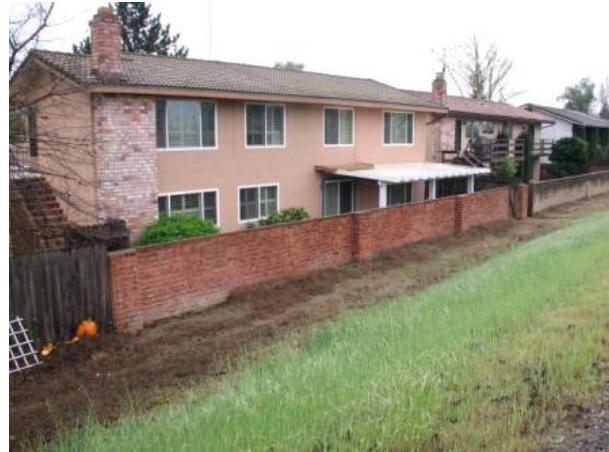
Levee Mile Report Line	131
Start Levee Mile	8.11
End Levee Mile	8.11
Location	Land Side
Category	Earthen Levee
Item	Encroachments
03/16/2012 Brick wall completely obstructs access and visibility.	
mkhashch_f_20130923_938.jpg

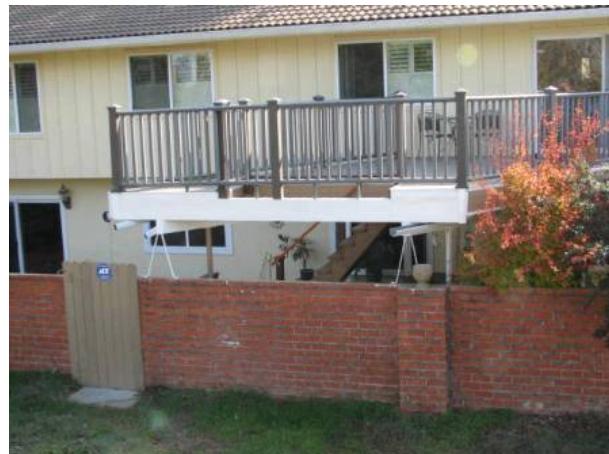
Levee Mile Report Line	132
Start Levee Mile	8.13
End Levee Mile	8.13
Location	Land Side
Category	Earthen Levee
Item	Encroachments
11/15/2011 Gutter drains that are suspended from the balcony direct flow onto the levee toe.	
mkhashch_f_20130923_065.jpg
